Diagnostic Procedures for Trend Monitoring System (TMS) Communications

MARCH 1979

MITRE Technical Report
MTR-4724

THE
MITRE
CORPORATION
HOUSTON, TEXAS

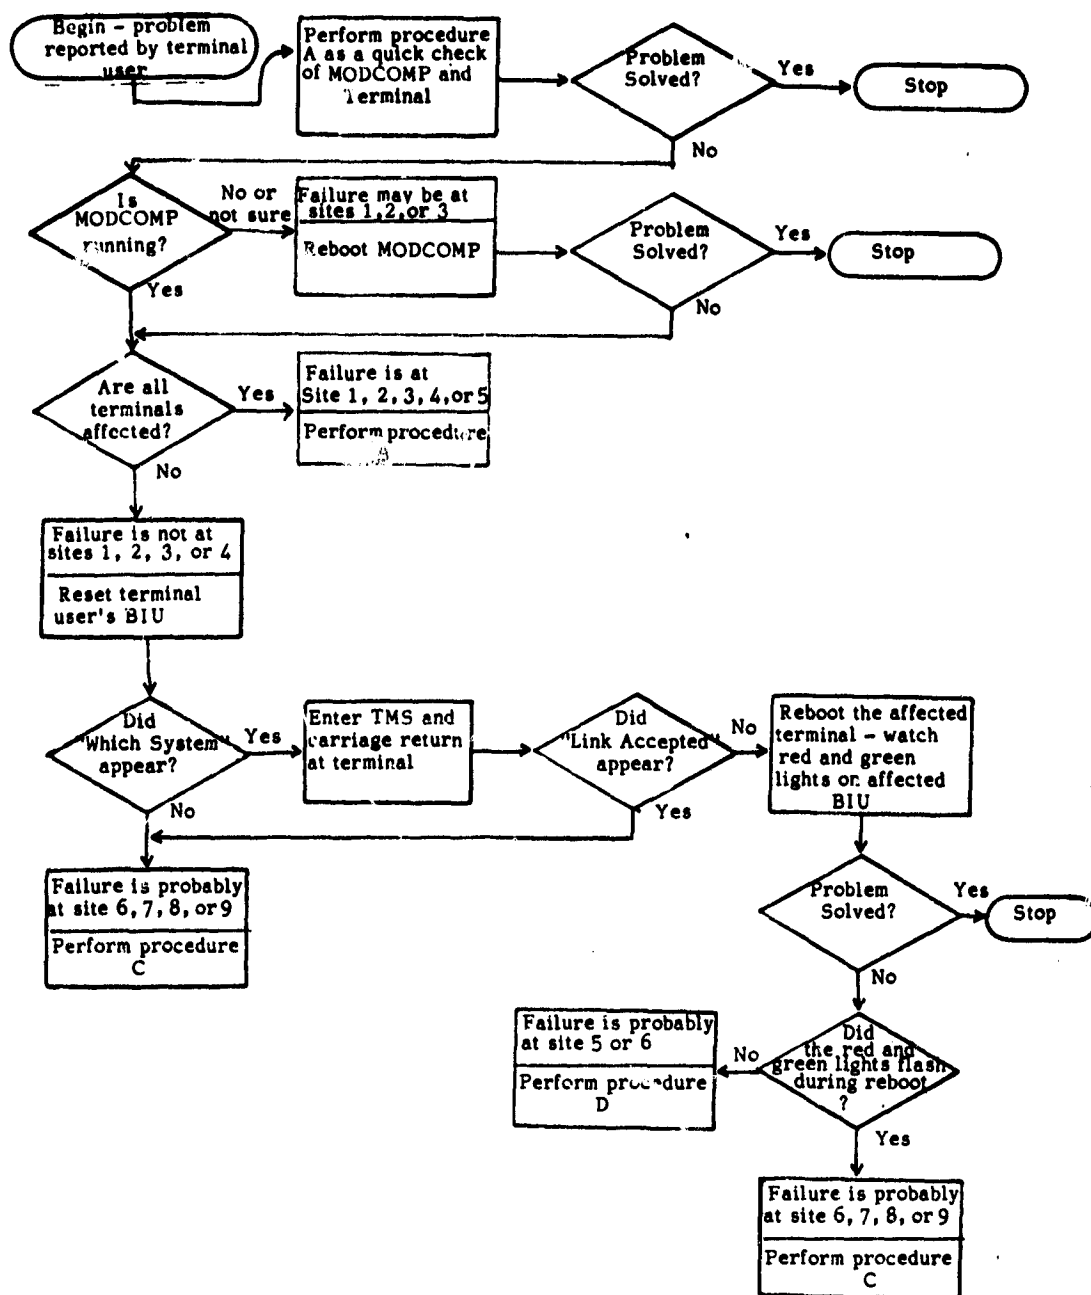
Figure 2.1-1 Top Level Diagnosis Procedure

The procedures in this section are intended to be used step-by-step for isolating problems and for correcting them by substituting components. Detailed instructions on the repair of failed components is beyond the scope of this manual, though a limited suggestion of an approach to the repair of BIUs is found in Section 111.

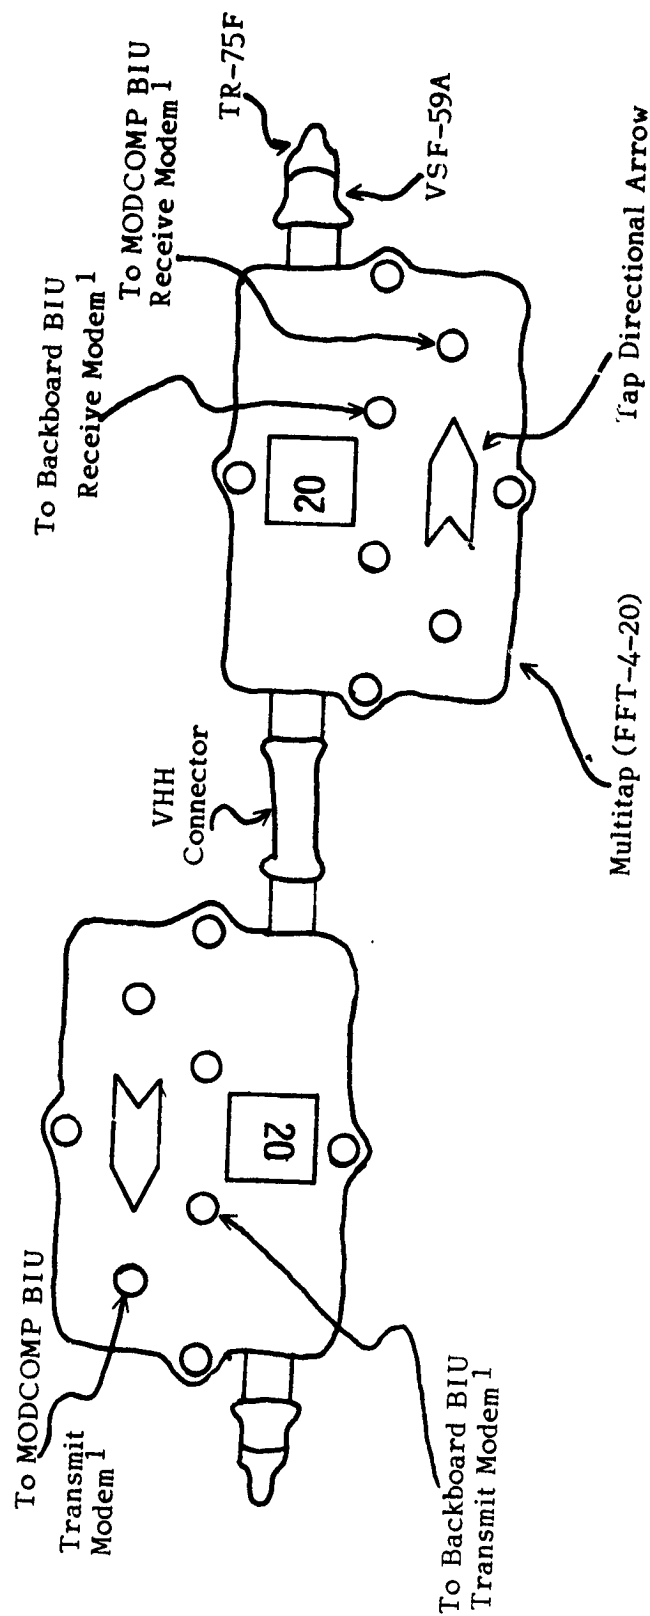
Figure 2.11-8 Structure of Bus Test Jig

Note 1: Any of the 4 RG-59 Connections on this tap may be used.

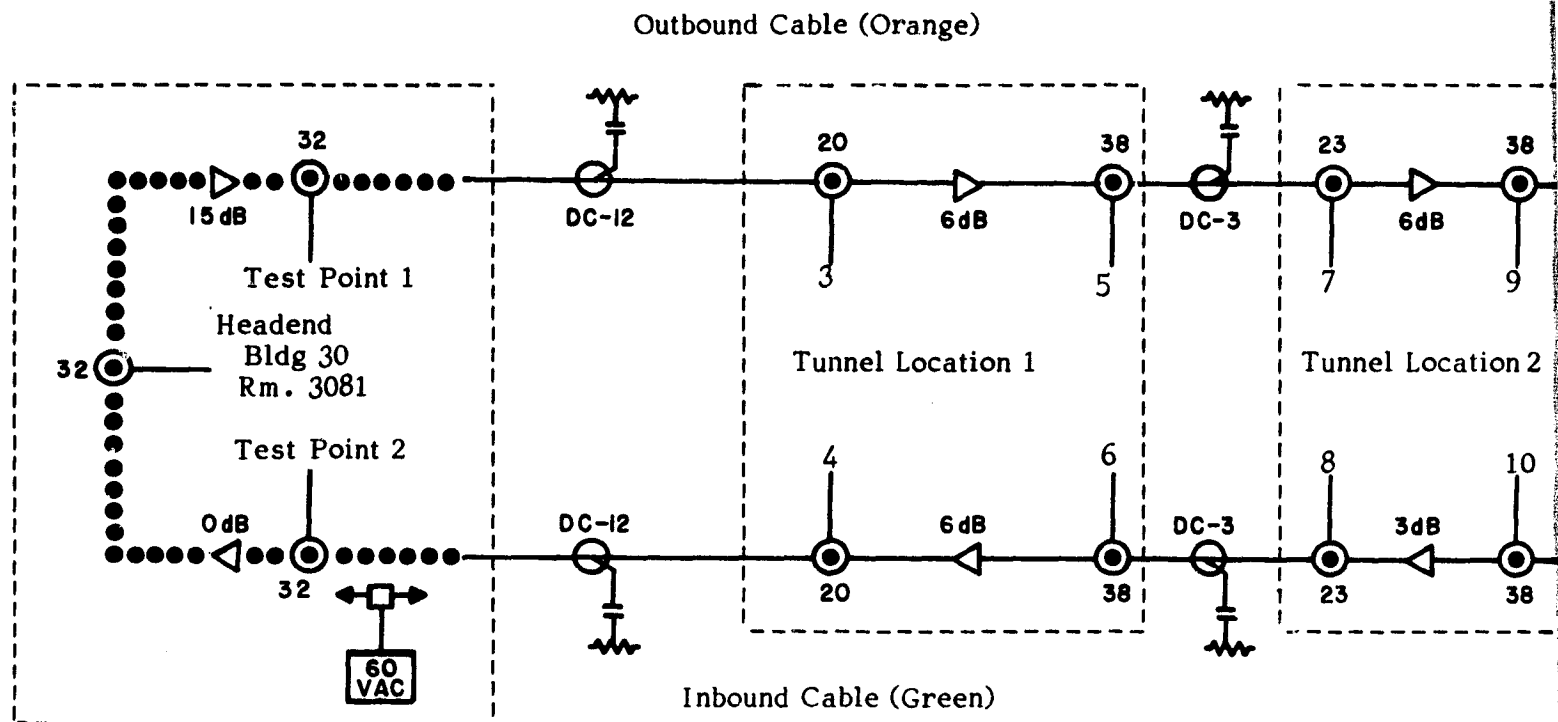
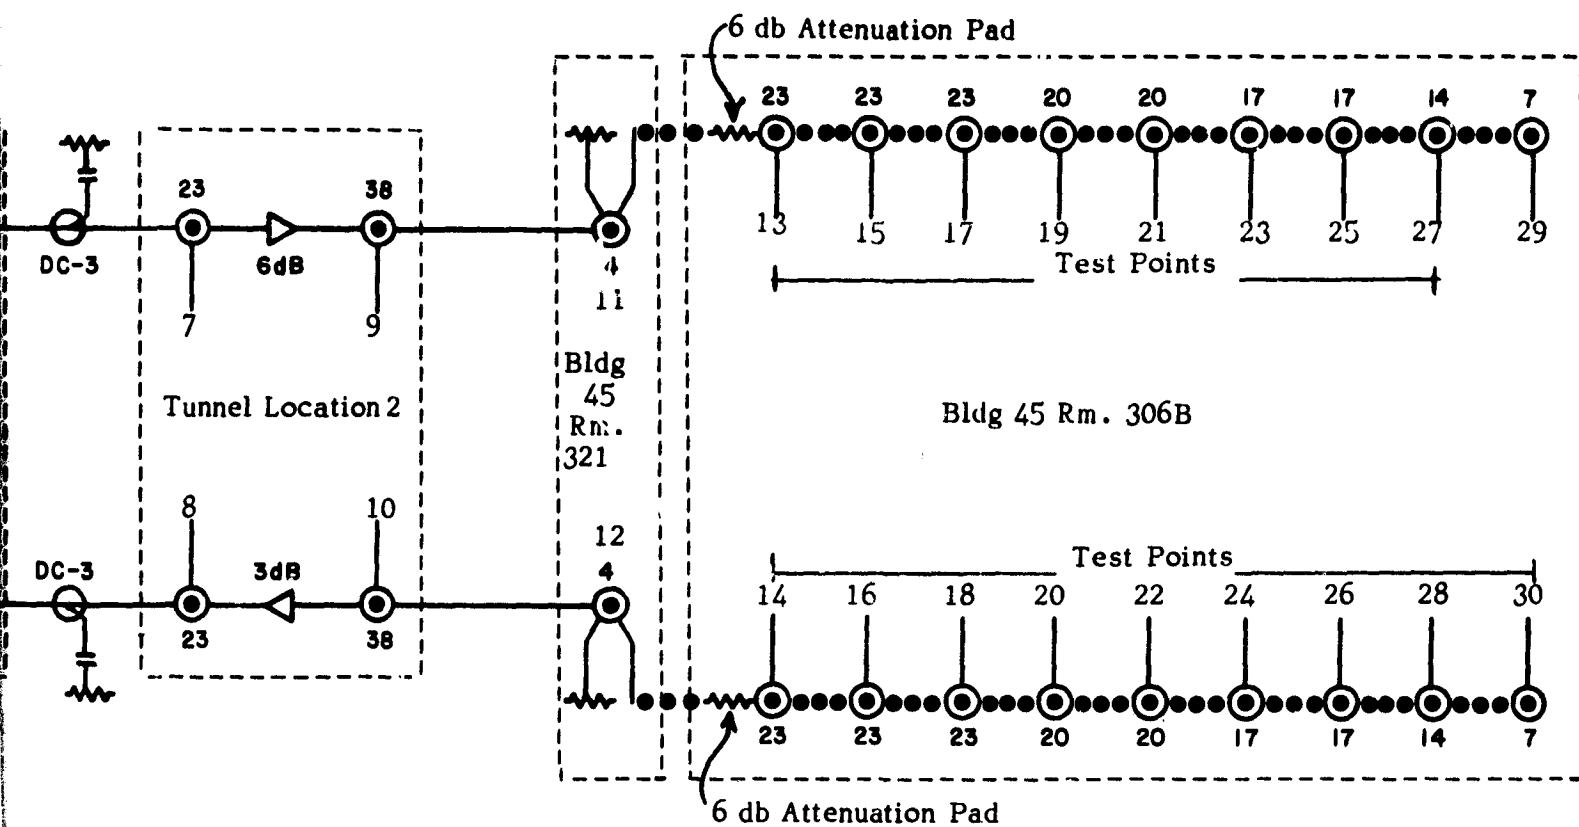
Figure 2.1-10 TMS Cable Network Schem

Key: Directional Coupler

ers beside amplifiers are
ation pad values

- Numbers beside multitaps indicate the tap values; numbers beside multitap drop connections are test point numbers

2. Use the MODCOMP test program VOLLEY to isolate the location of cable bus failure by following the steps given below. The locations referenced in the steps are keyed to the schematic diagram of the cable system shown in Figure 2.1-10 (more information about the cable system is found in [2]).

- d. If the failed component is a directional coupler, replace the interior part of the directional coupler (leave the shell in place) with a coupler of the same isolation (as shown in Figure 2.1-10).

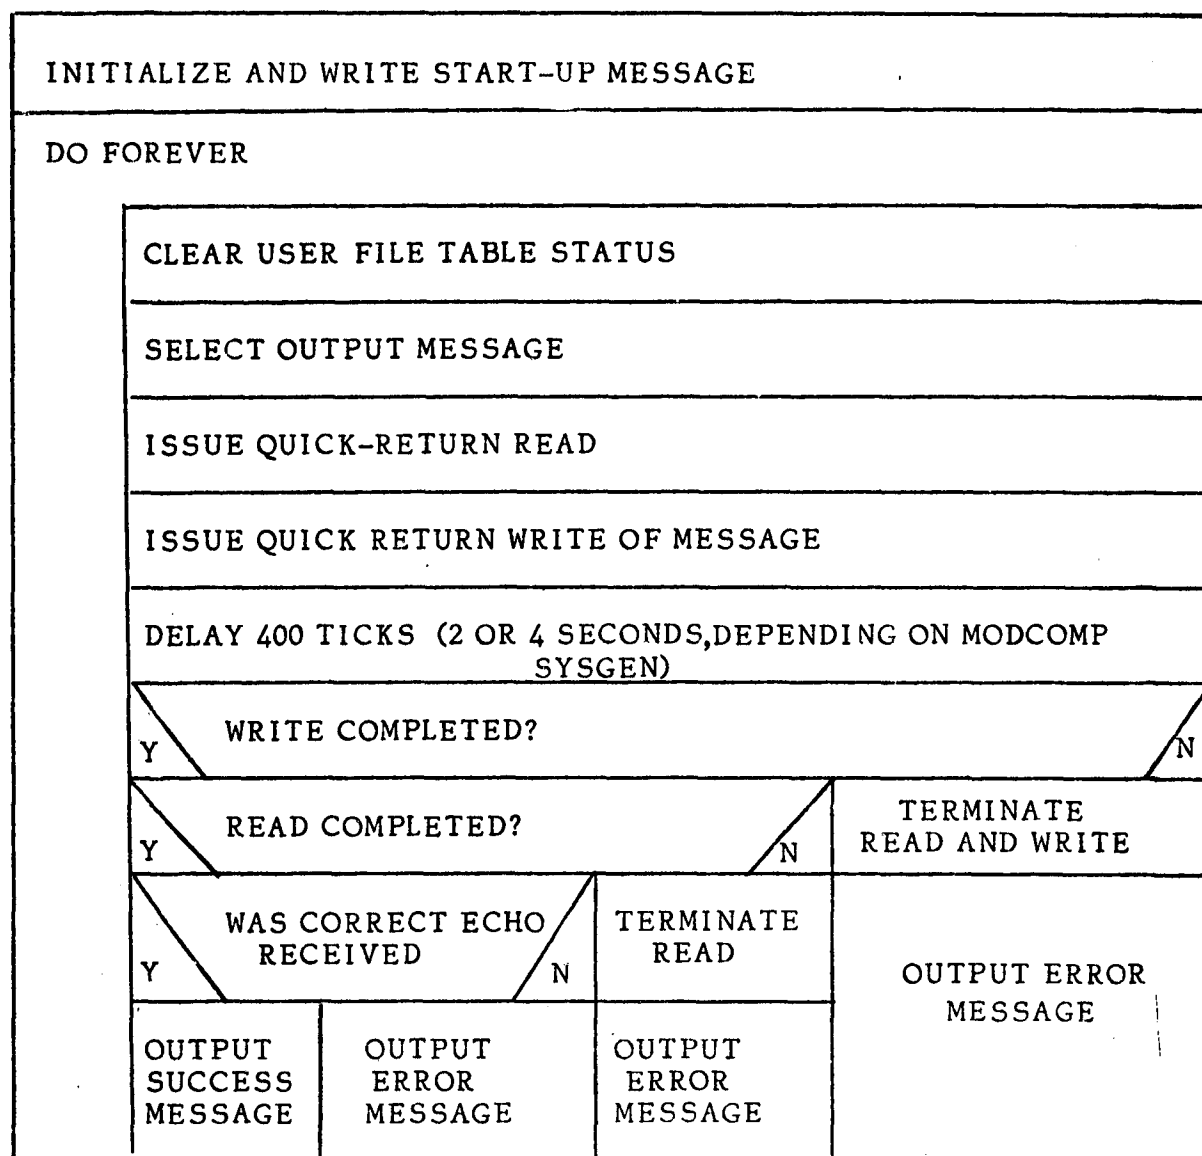
APPENDIX II
LOGIC DIAGRAM AND LISTING OF VOLLEY TEST PROGRAM
USED IN DIAGNOSTIC PROCEDURE F

The following diagram shows the logic flow of the program VOLLEY.
Conventions used in this type of chart are described in [12].

1 C THIS IS THE 'VOLLEY' TEST PROGRAM.
2 C
3 C ITS PURPOSE IS TO TEST REGULARLY TO SEE WHETHER THE BACKBOARD
4 C BIU CAN BE DETECTED ON THE BUS.
5 C IT IS INTENDED TO AID IN FINDING FAULTS IN THE CABLE NETWORK.
6 C IF ANY OTHER PROGRAM IS ACCESSING THE BACKBOARD FROM THE
7 C MODCOMP CONCURRENTLY WITH THIS ONE, RESULTS ARE UNPREDICTABLE.
8 C
9 C THIS PROGRAM IS INTENDED TO BE CATALOGED AS A STAND-ALONE TASK,
10 C AS DISTINCT FROM A BATCH OVERLAY. THIS IS BECAUSE THIS PROGRAM
11 C NEVER TERMINATES VOLUNTARILY, AND MUST ALWAYS BE ABORTED BY THE
12 C SYSTEM OPERATOR. MODCOMP PROVIDES NO FACILITY TO CANCEL RUNAWAY
13 C BATCH TASKS FROM THE BATCH INPUT FILE.
14 C
15 C HERE IS HOW TO INVOKE THE PROGRAM:
16 C     GO TO THE OPERATOR'S CONSOLE AND STRIKE CONTROL-'A',
17 C     TYPE IN : /VOLLEY/E,,TM
18 C     THEN STRIKE CARRIAGE RETURN.
19 C THEREAFTER, THIS PROGRAM WILL AT REGULAR INTERVALS EMIT A MESSAGE
20 C (TWO BYTES LONG) TO THE BACKBOARD (FILE 'NOB') AND WAIT FOR A REPLY.
